Manhole Inspection Summary

Manhole # S4100_003MH

Insp Date: **2/21/07 10:22 AM**

Location Address: **2208 ROBB ST**

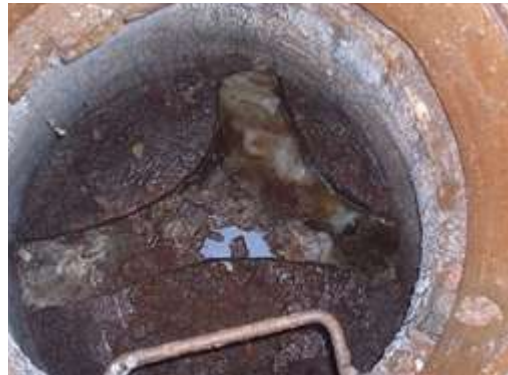
Top View

Evidence of surcharge - Bench debris.
Channel debris.

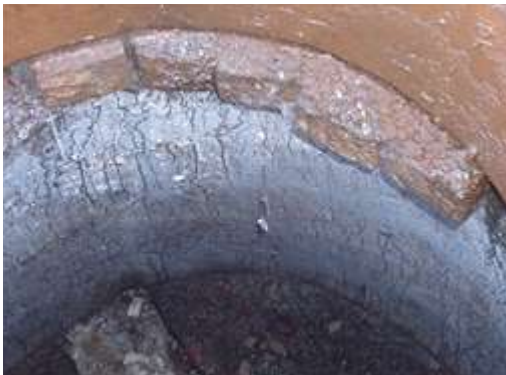
Defect

☒ **Leaks**

Condition: ☐ Sound ☐ Cracked ☐ Root Intrusion ☐ Loose Brick ☒ **Deteriorated**

Infiltration: ☐ None ☒ **Joint** ☐ Cracks ☐ Mortar ☐ Roots ☒ **Wall**

Frame leaks. Adjustment deterioration
and infiltration - other side.

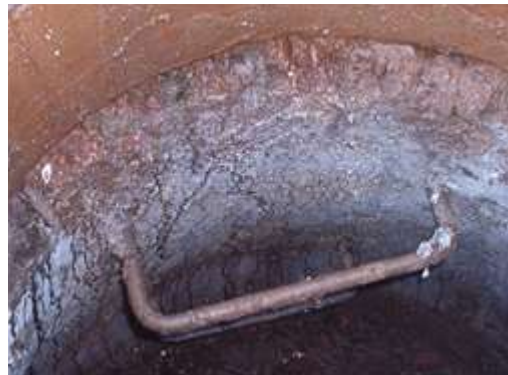
Defect

Frame leaks. Adjustment deterioration
and infiltration.

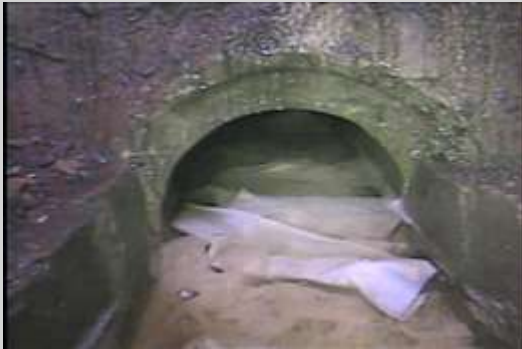
8 in. Circular Gravity Sewer Pipe Out @ 12 O'Clock

Deposits: ☐ None ☒ **Mud** ☐ Sludge ☒ **Debris** ☐ Grease

Silt Depth: **4** (in.) Deposits Extent: **Medium**

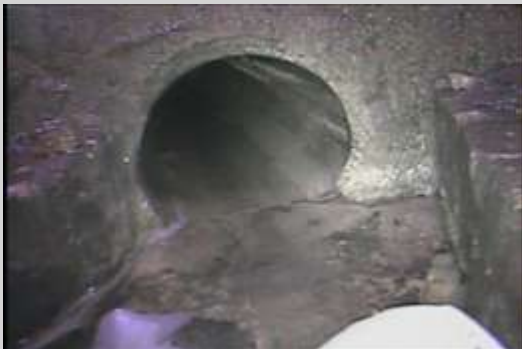
6 in. Circular Gravity Sewer Pipe In @ 4 O'Clock

Invert Depth: **5.60** (ft.) Flow Characteristics: **Slow**

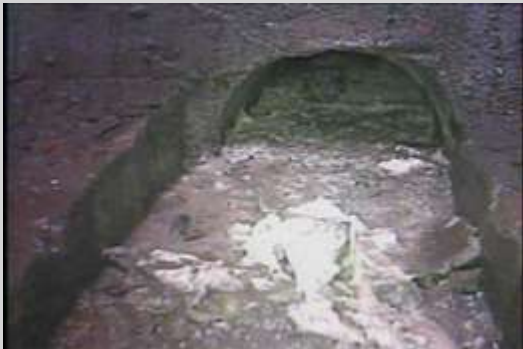
6 in. Circular Gravity Sewer
Pipe In @ 9 O'Clock

Deposits: ☐ None ☒ **Mud** ☐ Sludge ☐ Debris ☒ **Grease**

Silt Depth: **5** (in.) Deposits Extent: **Heavy**
